Disasters Caused by Severe Local Storms in Japan

ISHIZAKI, Hatsuo ...[et al]. Disasters Caused by Severe Local Storms in Japan. Bulletin of the Disaster Prevention Research Institute 1971, 20(4): 227-243

By Hatsuo ISHIZAKI, Yasushi MITSUTA, Tatsuo MUROTA,
YUZO YOSHIKAWA and In Whan SUNG

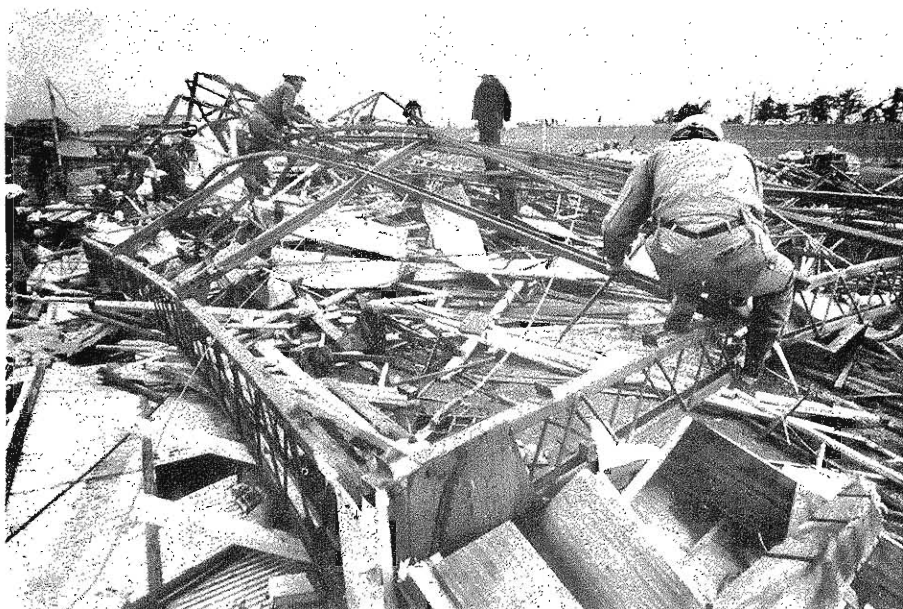
Photo. 3. Wreckage of a light-gauge-steel structure. Bodily removal of the structure from its foundations. (by courtesy of the Mainichi Newspapers)

Wooden or steel structures were more seriously damaged (Photos 2, 3 and 4). Reinforced-concrete buildings suffered damage only at openings. The general features of the damage were similar to those caused by the strong winds of typhoons, but severe local damage caused by heavy debris, as shown in Photo. 5 was often observed.
